CAPTAIN OLIVER FILLEY

HOUSE

ARCHAEOLOGICAL STUDY

SPRING/SUMMER of 1999

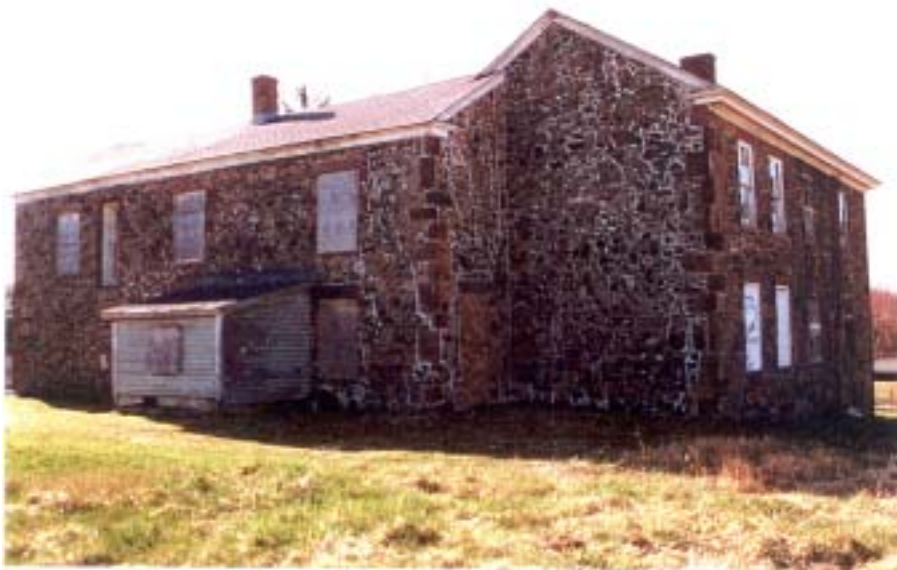
PHOTO 2 - NORTHSIDE VIEW

Viewing the total landscape, both the study area and the surrounding fields, it is evident that the soil in the study area has been regraded. We know from the "Feasibility Study" of May 1995 on page 5, the Town of Bloomfield graded the northside to direct drainage around to the westside (Photo 2). Obviously, this excavation episode has effected the artifactual integrity of this portion of the site.

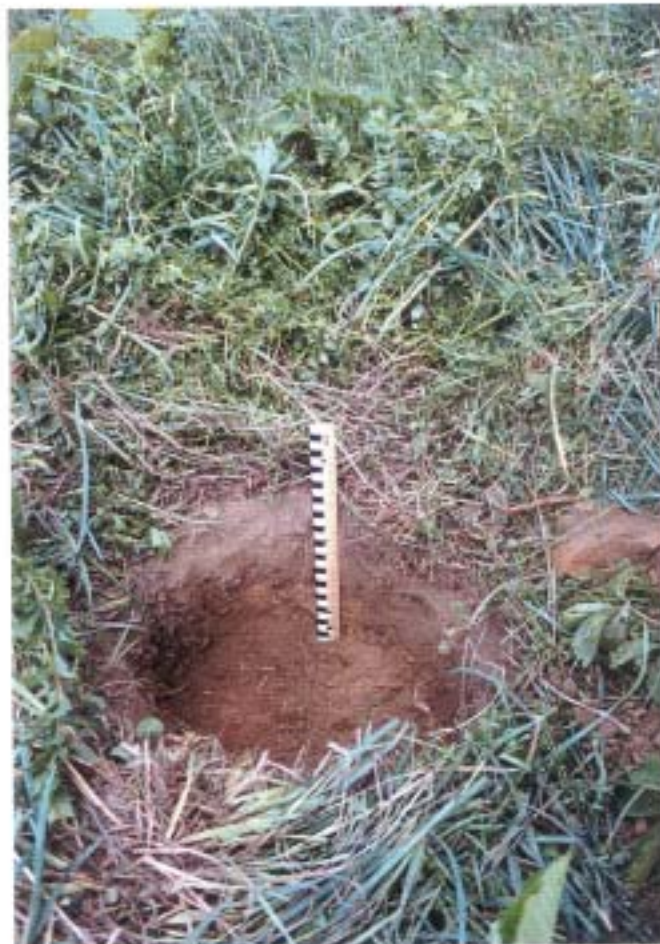
PHOTO 4 -

Digging commenced in April and continued until August for all 3 phases. In order to compare the soils of our study area with the relatively undisturbed area outside, a control pit (Photo 4) was dug in the field northwest of the house (Drawing 2). This control pit reveals 5 inches of topsoil before a hard packed subsoil takes over.

CONTROL PIT

All of the test pits showed a typical stratigraphy of 3 inches of topsoil and then hard packed gravelly subsoil to our final depth of twelve inches. Compared to the control pit, the top soil is 2 inches less. This is no surprise because we know of the regrading that went on in the rear of the house and this may have also occurred in the front. I think a soil expert might be consulted to get his thoughts on how long it takes for organic decomposition to build the topsoil layer on land typical of our study area.

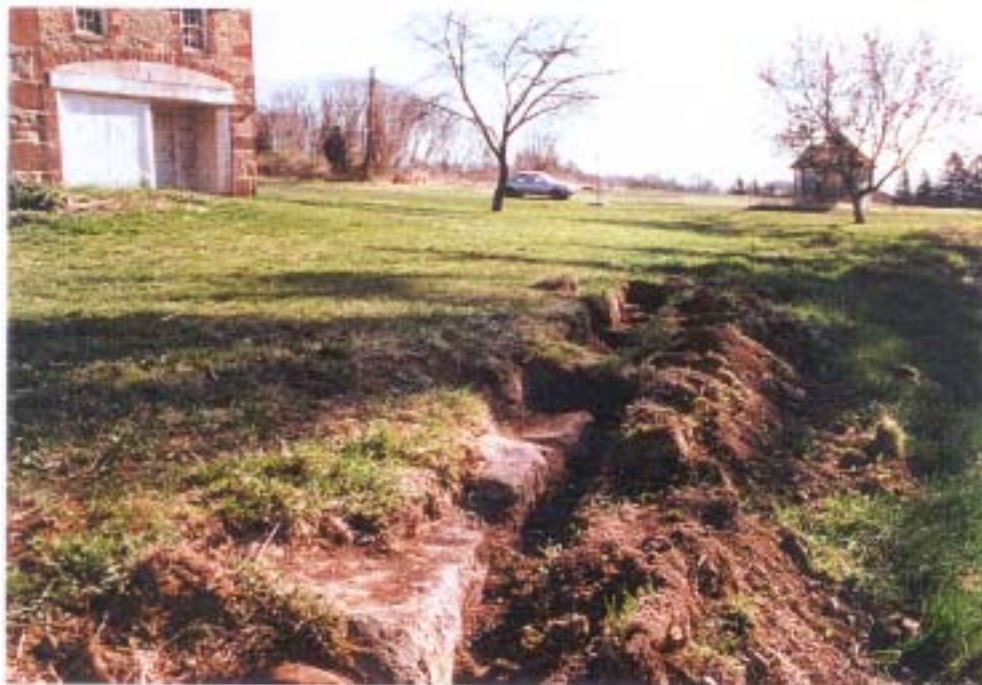
We began our first digging a few days after the town came in with a backhoe to test for a possible location of the septic system. They did some mild surface scraping in an area on the southwest corner edge of the mowed area and uncovered some very large brownstones. When we arrived for our Saturday morning digging, we expanded this area and the wall shown in Drawing 1 and Photo 5 was revealed. The larger stones lie westerly and get smaller in a easterly direction. Our first thoughts were that this maybe foundation remains of an earlier structure. Areas at the walls extremes were wire probed in all directions, but didn't reveal anymore large stones. Therefore, what we uncovered appears to be some kind of a retaining wall. Whether it served a functional value other than decorative couldn't be determined.

PHOTO 5 - UNCOVERED STONEWALL

The two most interesting features, of Phase I are the brownstone wall and the possible evidence of a defunct septic system. For the time being, these are features that need noting in case of some further study or find can relate to them.

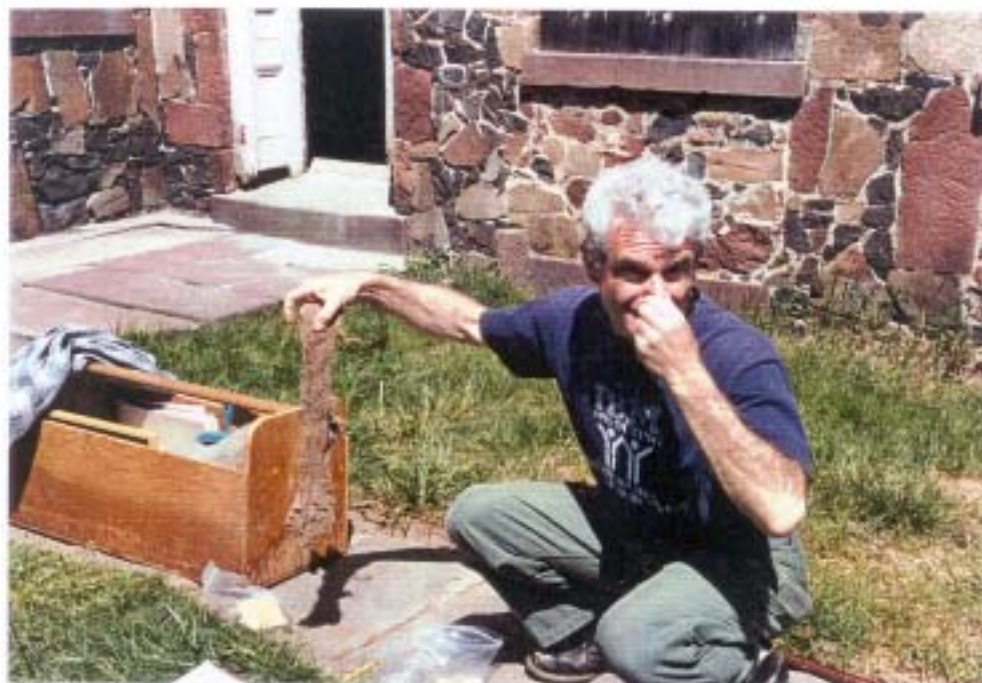
PHOTO 6 - TEXTILES REMAINS, SOCK

Surprisingly for a house and property that has been lived on nearly continuously since at least 1834, its soil contains few artifacts. Additionally, PHASE I test pits yielded few artifacts dating earlier than this century. For example, a recovered penny and a dime had dates of 1947. Other finds were a Maxwell House coffee can and typical 20th century pottery and glass shards. There were but a few artifacts typical of 18th and 19th century such as one ceramic pipestem, and a few redware and creamware shards. In fact Photo 6 shows a sock that was uncovered. Textiles normally decompose rapidly in our acidic soil and I would guess not last longer than 10 or 20 years.

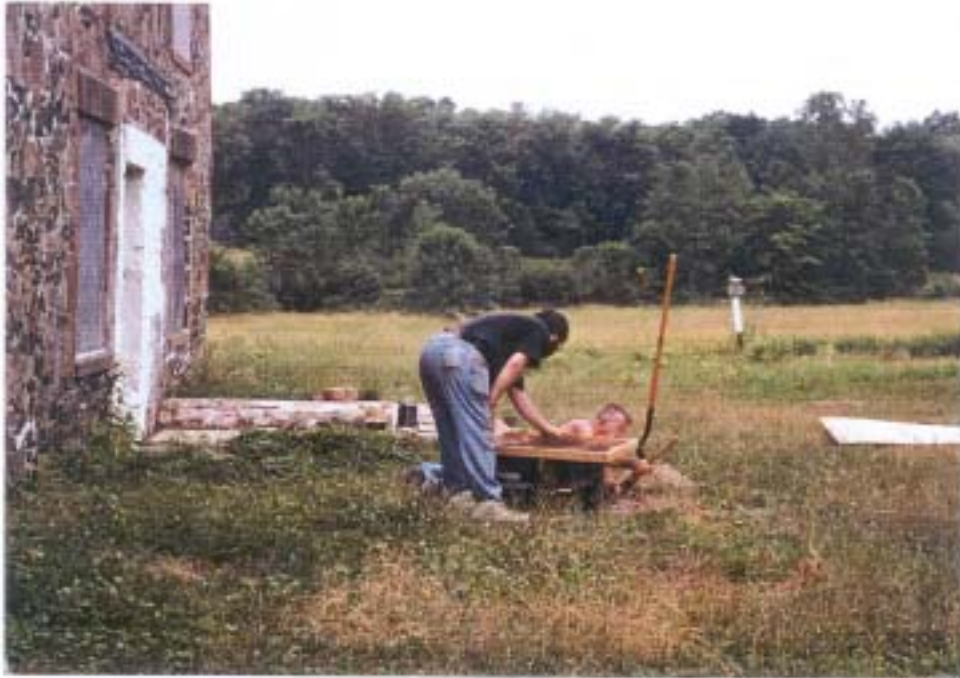
PHOTO 7 - THE DEDICATED BRUCE HALES

WORKING IN PHASE II

This phase covered the area shown in Drawing 2 and PHOTO 7. It consisted of 17 evenly spaced test pits. We retrieved artifacts similar to what was found in PHASE I and listed in Phase II (Appendix B). There were representative amounts of coal and clinkers, pottery and glass shards, and food remains (namely bone of butchered meat). Again, the shards were small, indicating redepositing and trotting upon as alluded to earlier. Of course this should be no surprise because of the grading the town recently did here and mentioned in the Initial Observations section.

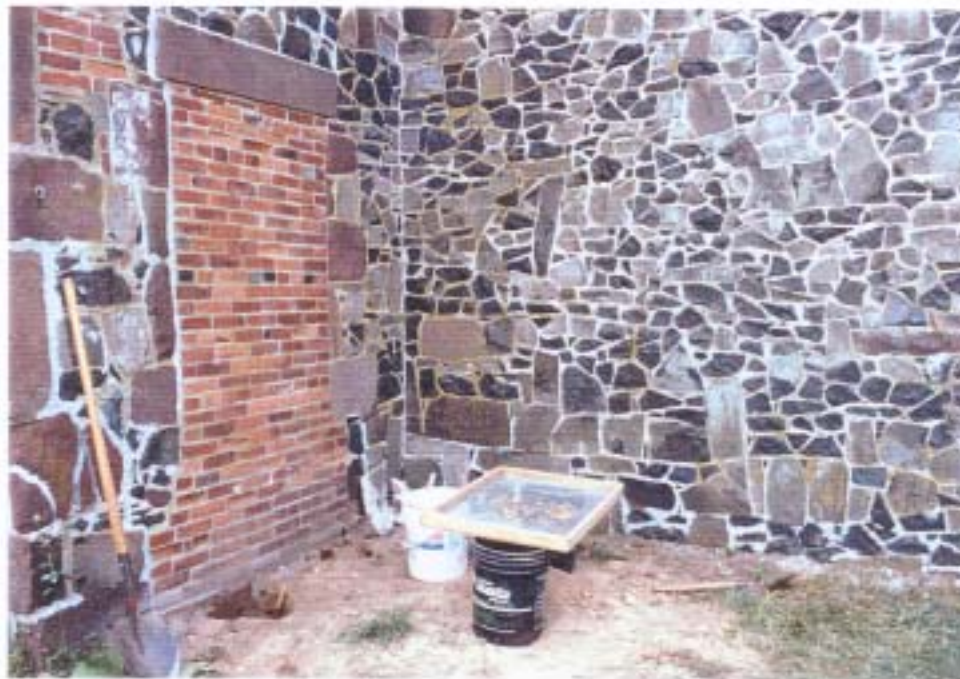
The most interesting feature that came out of Phase III can be seen in Photo 8 and its closeup in Photo 10. A hole dug at the stoop of the northwest bricked in door reveals a flatstone like those in PHASE II's test pit 8 and 12. If one takes a close look at Photo 15 reference B, taken in 1913, they can just makeout a structure in the northwest corner of the house. It appears that the now bricked in doorway led from the kitchen to the long structure shown in the photo via a connecting structure built atop the foundation that now

PHOTO 8 - THE NORTHWEST CORNER

OF THE HOUSE

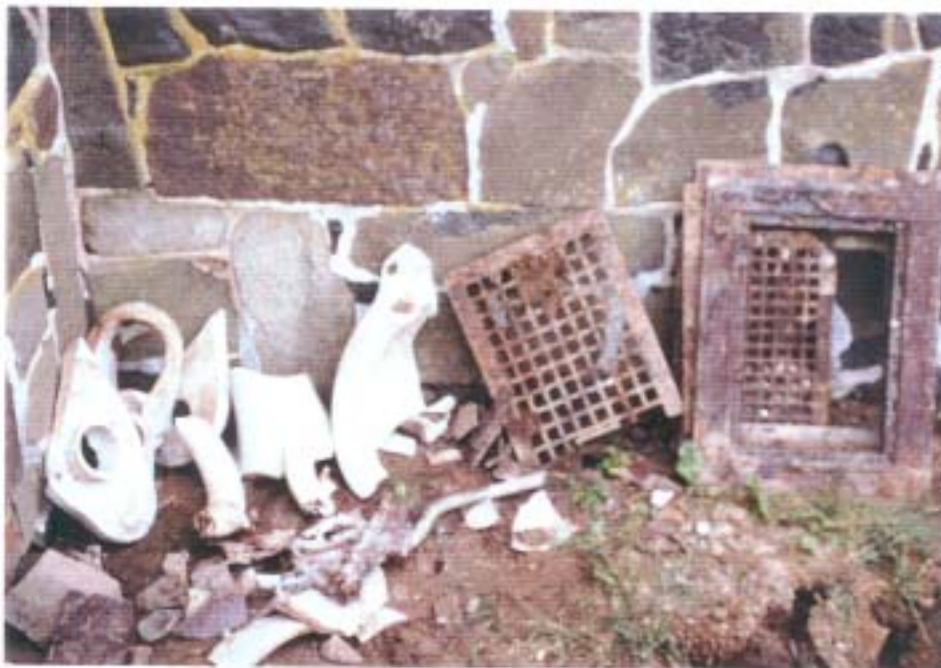
Test pit 1 is an area that Archaeological Research Specialists (ARS) recommended in their final report to further pursue. What started as a normal size test pit grew in size because of the large artifacts that this test pit exposed adjacent to it. Photo 9 shows many of the items retrieved. I would speculate that the broken commode seen here came from the bathroom that once existed off the kitchen, as shown in the "Feasibility Report" of May 1995 on page 5. Therefore, this would indicate these items were probably dumped here quite recently. Further, the soil in this area was loose and the easiest digging on the site this season.

PHOTO 9 - REMAINS FOUND IN NORTHWEST CORNER

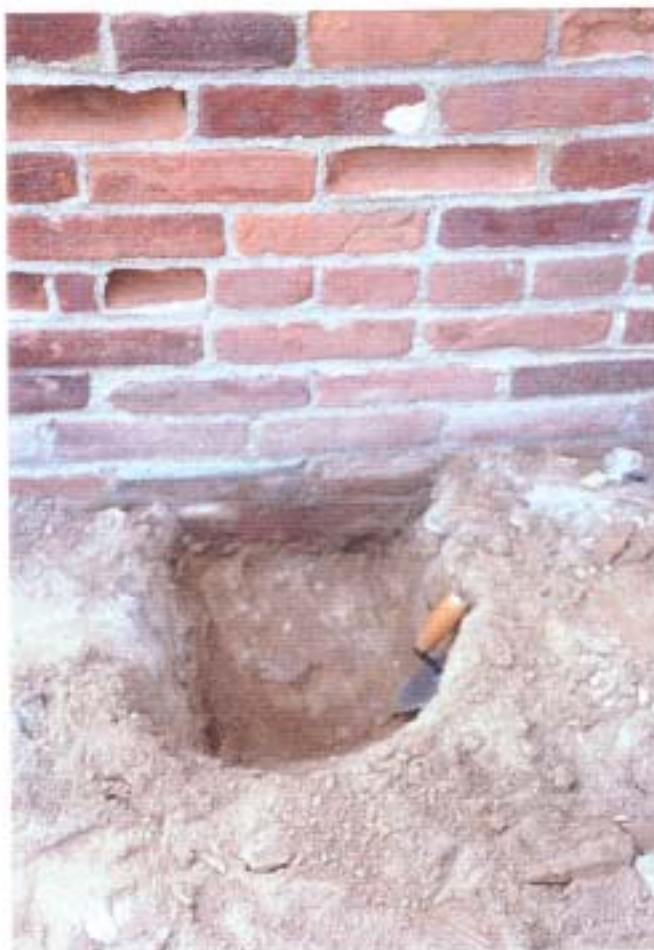
PHOTO - 10

FLATSTONE BY

BRICKED UP

DOORWAY IN

NORTHWEST

CORNER

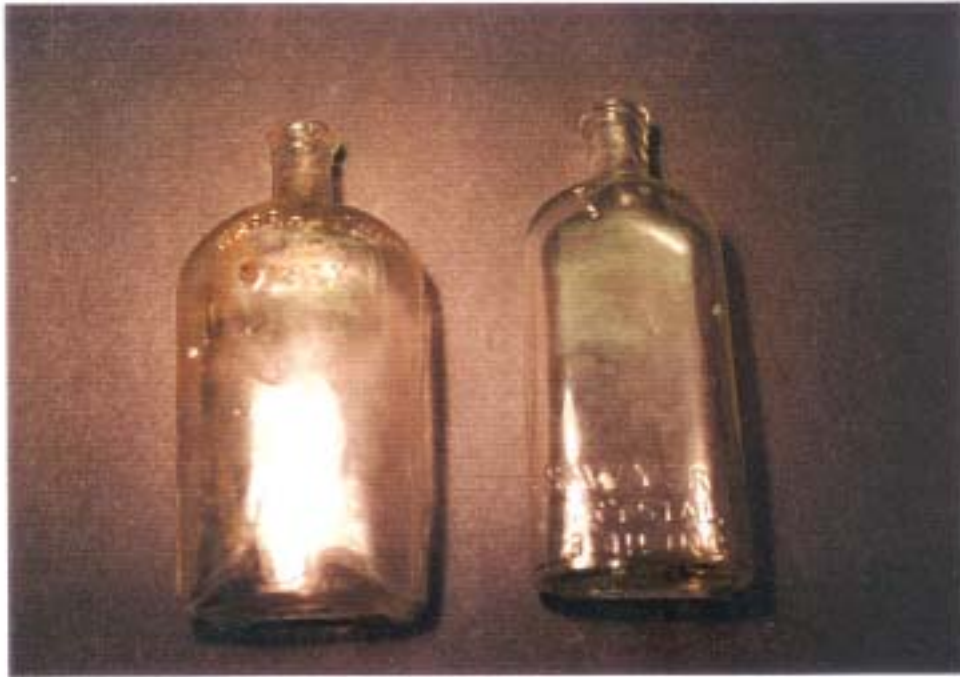
Also in the same context were several complete bottles. It puzzles me why someone threw since they certainly worthy collector items. Two of the most noteworthy bottles are seen in Photos 11, 13, and 14. They have embossed on them; "Warranted Flask" and "Sawyer Crystal Blueing" respectively. Referring to "American Bottles and Flasks and Their Ancestry" by McKearin and Wilson (see bibliography), the "Warranted Flask" bottle appears to date back to the middle 19th century. The Sawyer bottle is also interesting and may date back to the turn of the century. Laundry blueing was the

PHOTO 11 - WARRENTED FLASK ON LEFT, SAWYER CRYSTAL BLUEING
ON RIGHT

standard until bleach became available. Additionally, even if the flask was late 19th century, it was found in the same context as the later artifacts dumped with it. It follows the axiom that a test pit or a stratigraphic layer is no older than its latest dated artifact. Therefore, these bottles appear to serve no meaningful purpose in our archaeological study. Since these items were dumped here quite recently, maybe someone in the Historical Society might want to investigate the who and why of this episode.

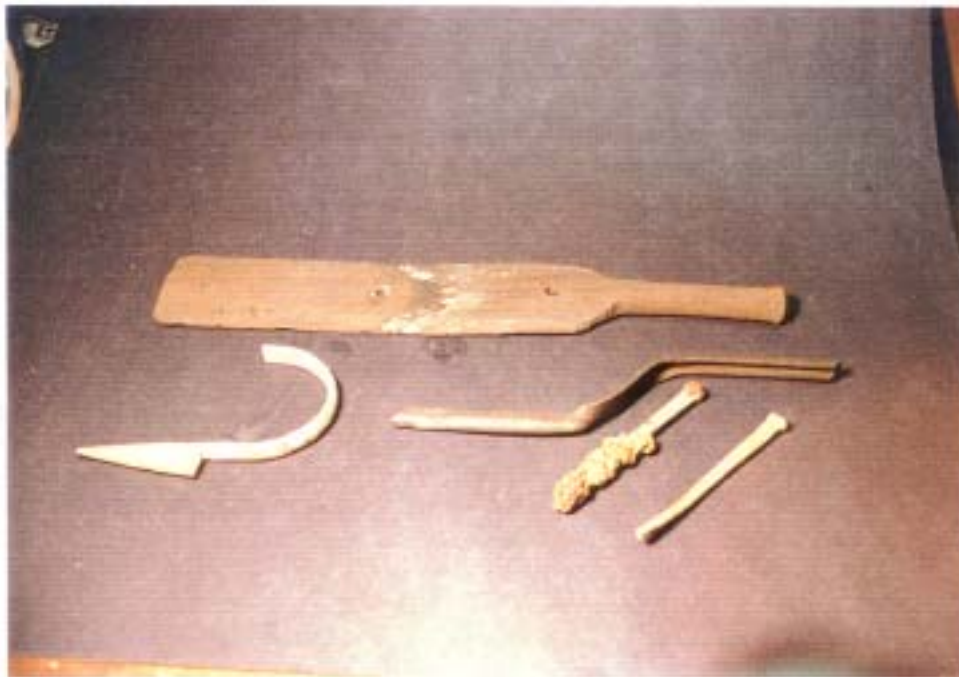
Other items of interest found in this area are shown in Photo 12. On top appears to be a chisel and below it a mortar repointing tool. They both are appropriate tools for repairing and maintaining this stone home.

Also in Photo 12 is a copper downspout hanger of unique shape. This hanger mates with remains of downspout sections we recovered in this area. I assume they were once attached to this house.

PHOTO 12 - POSSIBLE A CHISEL ON TOP, DOWNSPOUT HANGER IN LEFT
HAND CORNER, MASONARY REPOINTING TOOL AND 2 CUT NAILS

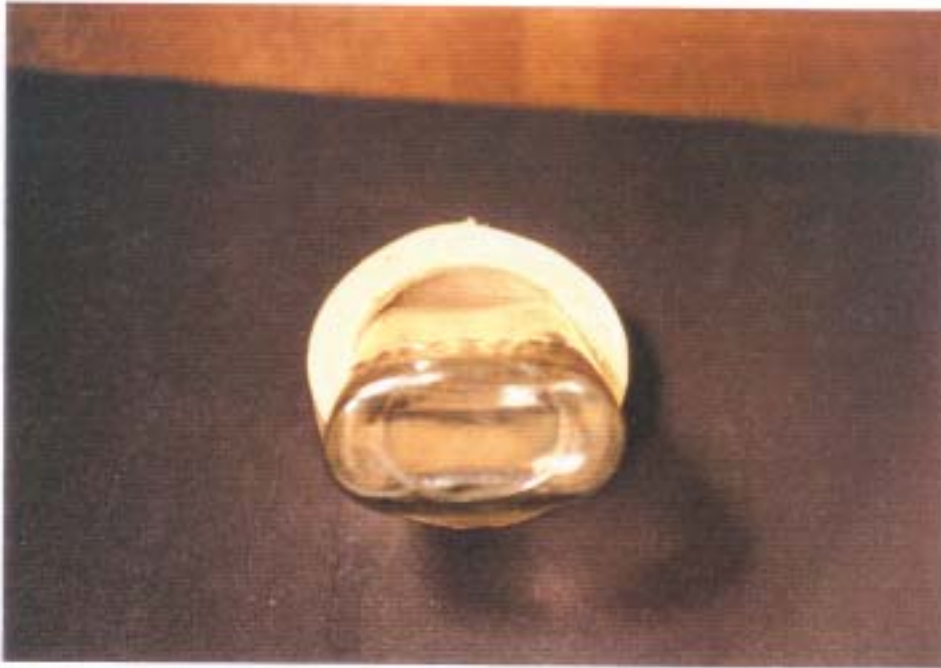
PHOTO 13 - BASE OF SAWYER BLUEING BOTTLE

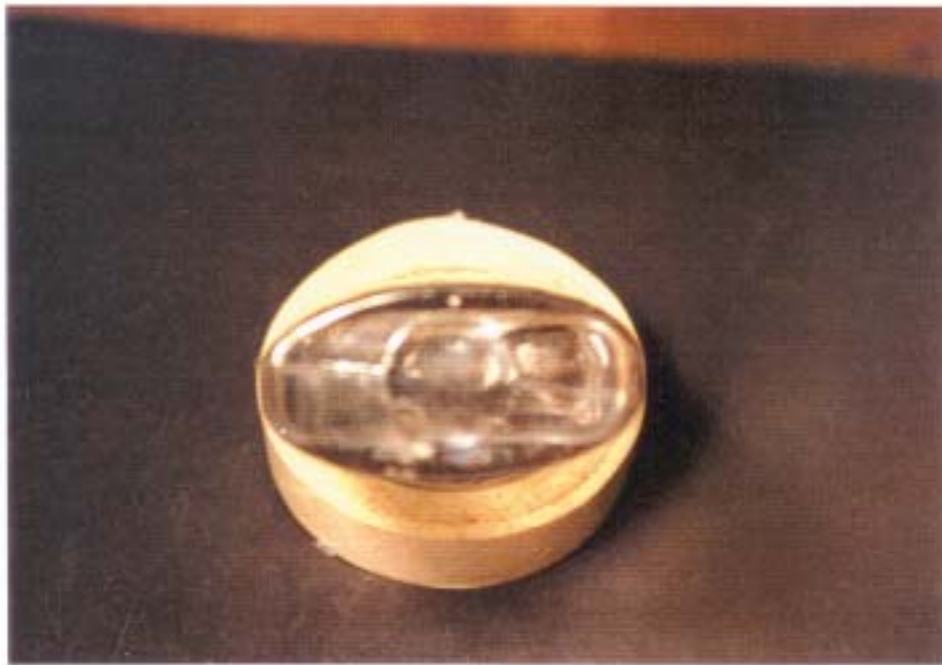
PHOTO 14 - BASE OF WARRENTED FLASK
